# Post Flight Analysis Report

## Project TELL - Spaceport America Cup 2018

<b>Doc. Reference</b>	TELL_FR01_Post_Flight_Analysis_01
<b>Author</b>	Alex Schmid (alexschm@student.ethz.ch)
<b>Co Authors</b>	Anna Kiener David Haeusermann Bruno Frutig Ziga Brencic
<b>Date</b>	17-May-2019

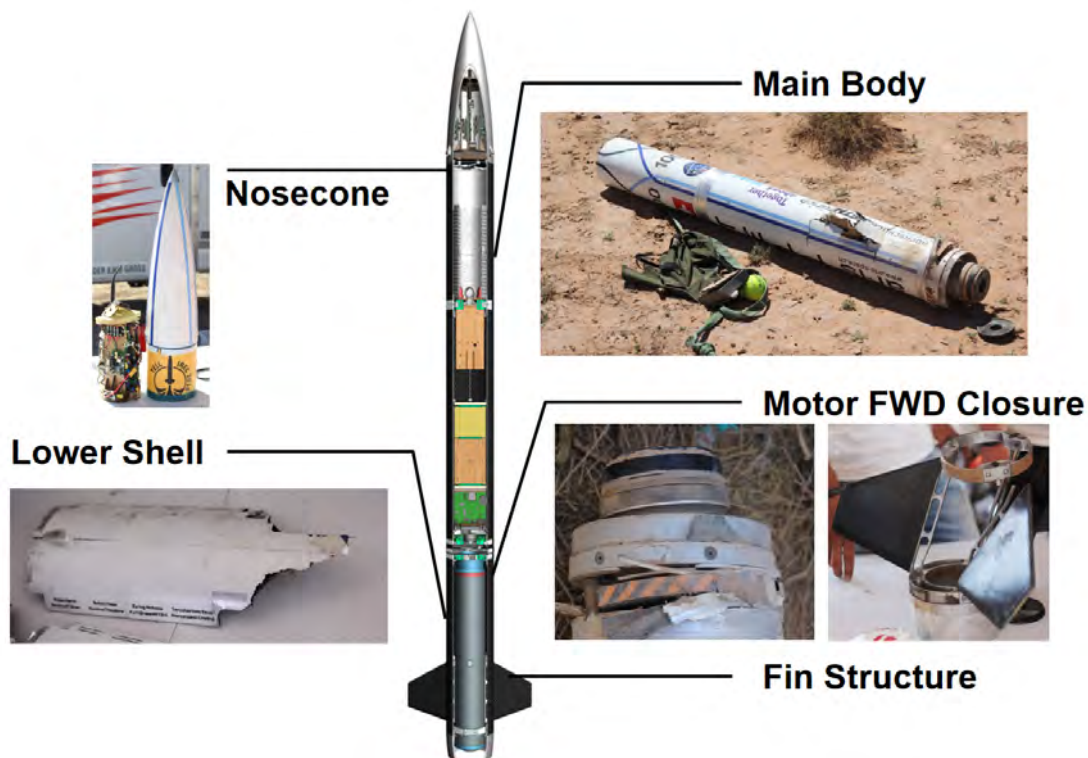
Figure 4: Overview of the found remainings of TELL

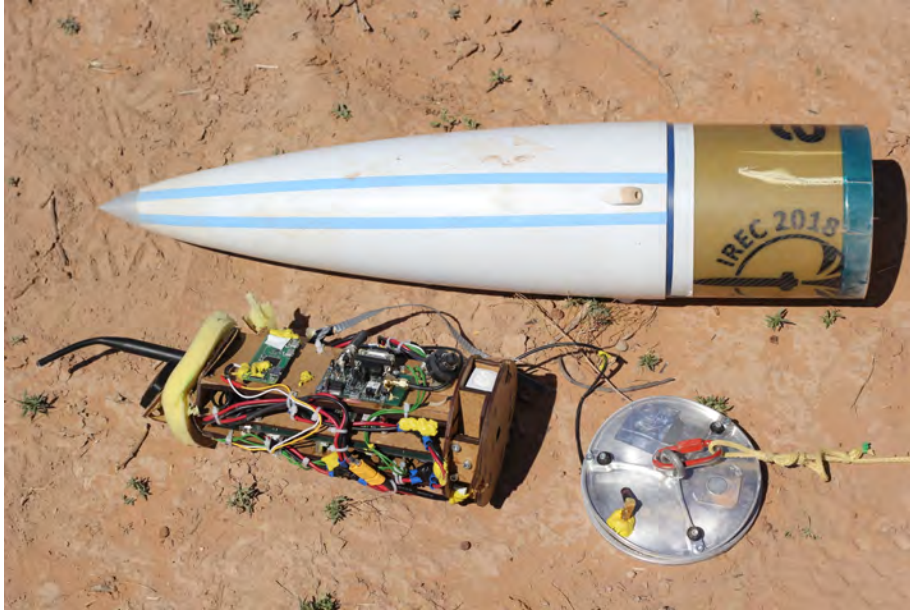
The nosecone glassfiber structure only showed minor signs of damage. The only obvious damage is the vertical cut along the coupler section (see Figure 5). The bulkring disintegrated from the nosecone structure (see Figure 6). However, the drogue parachute was still attached to the nosecone bulkhead. For more information on the nosecone contact David Haeusermann of Project TELL.

Figure 5: The glassfiber structure is mainly intact, vertical rupture at coupler section. Bulkring separated from glass fiber structure. Avionics module was removed from the nosecone for disarming process

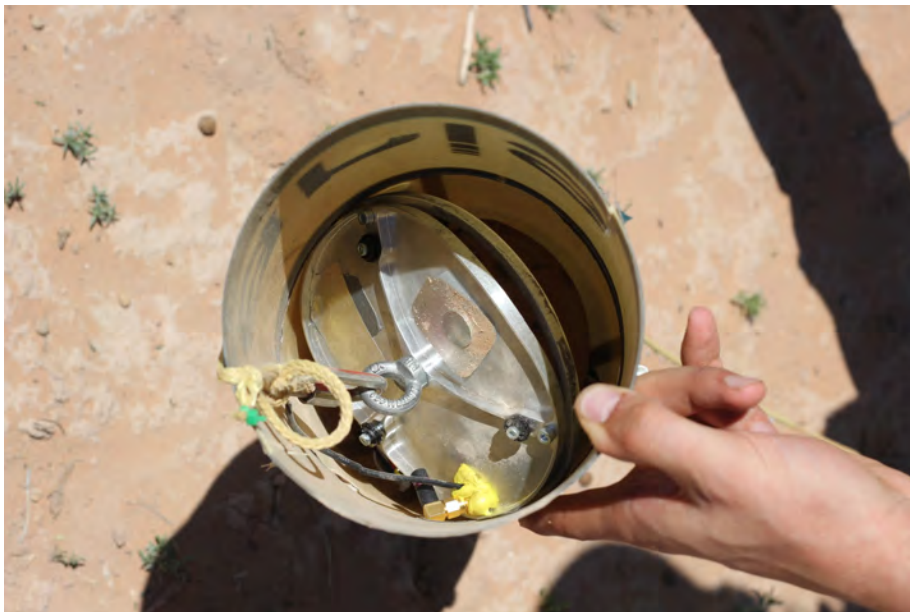
Figure 6: The bond of the bulkring to the glass fiber structure failed. Drogue parachute still attached to the nosecone bulkhead. The Figure shows state at recovery

The minor damage of the nose cone is most probably due to the fact that the drogue parachute was still attached to the nose cone which slowed the descent rate. Most probably the bulkring was still attached to the glass fiber structure during the descent of the nose cone. It was bonded behind the recess for a smooth transition from the nose cone to the parachute tube above the coupler section. Therefore the attachment of the bulkring was a form fit which hindered the rupture of the bulkring out of the glass fiber structure opposite the direction of intended launch. Obviously the bond did not secure it sufficiently in the opposite direction which led to a rupture of the bond line during ground impact.

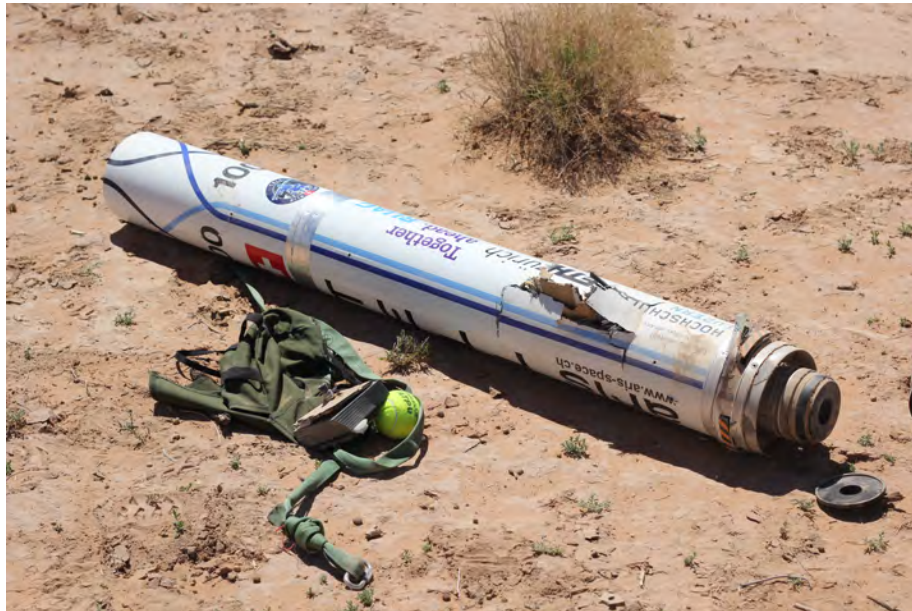
The Middle Section was the most damaged part of the rocket (see Figure 7). The compact ballast mass of 4.25 kg, located in the center of the Middle Body, crashed through the whole Middle Body due to the landing shock. On its way, it compromised the complete inner structure. It did not only damage the payload and lower body avionics, which were located right below it, but also the carbon fibre shell of the rocket itself (see Figure 8).

The air brakes were mostly damaged due to the over-pressurization and explosion of the COTS motor, as they were located right above the fixation of the motor.

Figure 7: The Middle Section of the Rocket TELL at ground recovery

As conclusion it must be stated that a payload functioning only as dummy mass with a weight of several kilos is critical, as well as its placement above sensitive systems as the scientific payload or the lower body avionics.

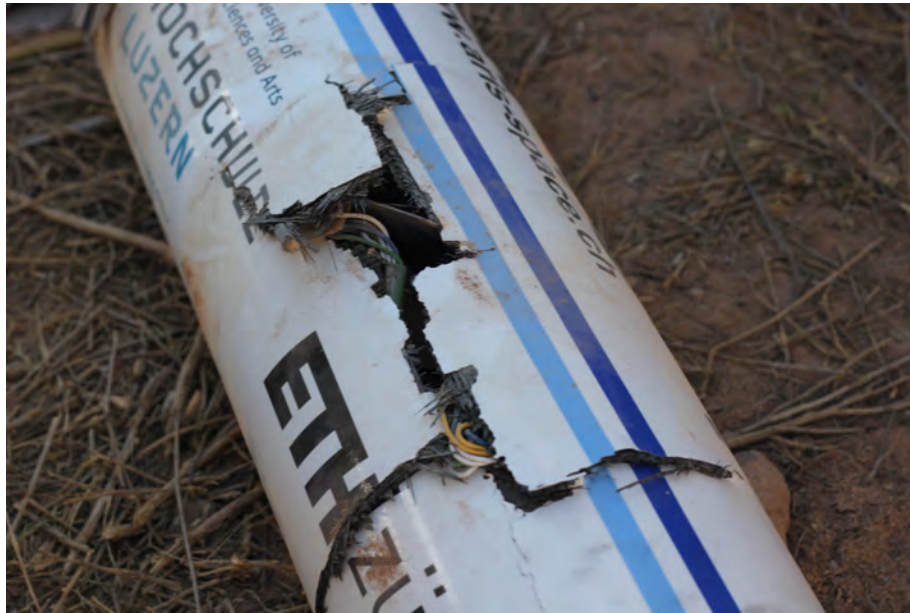
Figure 8: The Hole caused in the airframe by the ballast mass

It is suggested to have more strict mass requirements for the scientific payload. Furthermore, several locations within the rocket shall be designed to add or remove spare weight easily. Also, no low cost MDF shall be used for structural parts (as it was used for the lower body avionics and also the structure of the dummy mass).

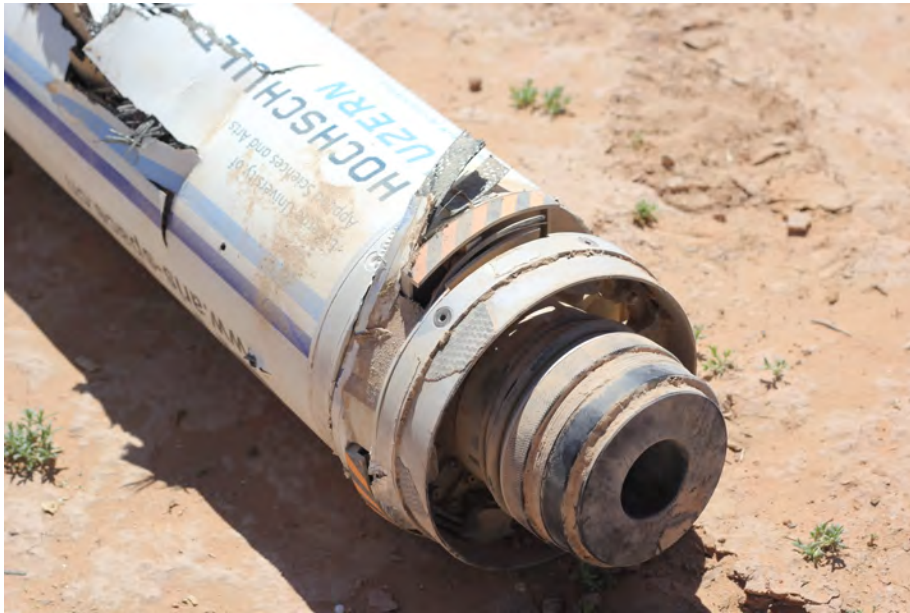
The lower airframe disintegrated due to the explosion of the motor located inside. The motor adapter as well as the front closure were still attached to the motor bulkhead (see Figure 9). However, the bond joint of the carbon fiber tube and the field joint was destroyed. The field joint itself was still firmly bolted to the motor bulkhead.

Figure 9: The lower body after touch down: The Motor adapter and motor front closure are still joined and also attached to motor bulkhead, while the field joint separated from the carbon fiber tube

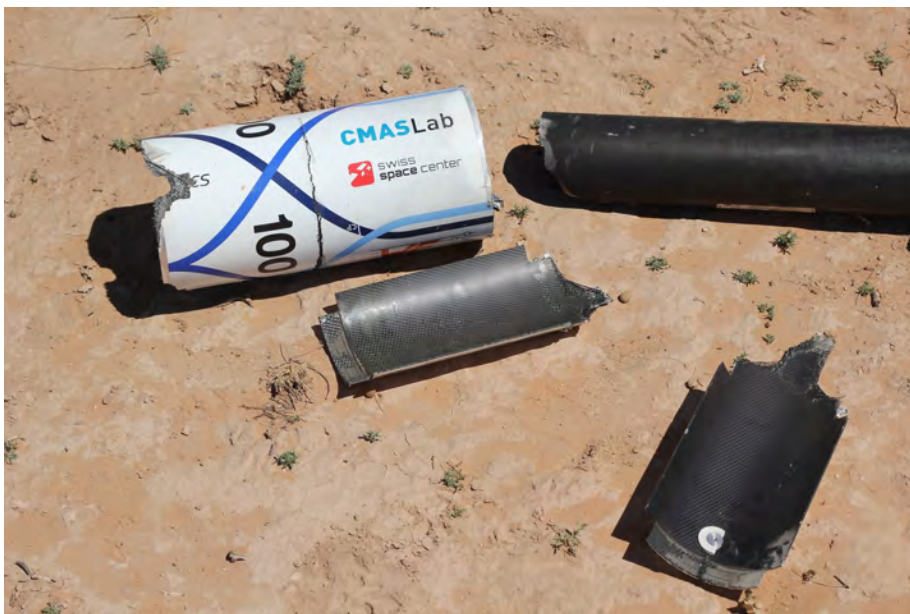
The carbon fiber tube was ruptured and recovered in four pieces. The sections in between the fins were torn from the remaining tube. The rupture occurred from the edges of the cutouts for the clamps at an approximate angle of 45 degrees (see Figure 10). Furthermore the remaining tube shows a rupture along half of the circumference.

Figure 10: The lower airframe with the liner insulation of the motor (top right) and two carbon fiber partitions and the recovery location

The cause for the rupture of the lower airframe tube is the pressurization of the airframe after the explosion of the motor. After the explosion burning propellant was observed. Usually the propellant is extinguished due to the sudden pressure drop in case of a closure failiure. During the investigation of the debris and the discussion of the observations it was mentioned by a judge that the occurrence of burning propellant after the explosion underlines the sturdy construction of the lower airframe as it could withstand a certain level of pressure before rupturing.

It is assumed that the pressurization caused the carbon fiber sections in between the fins to rupture simultaneously, releasing the fin can from the lower airframe. The rupture was initiated at the sharp corners of the cutouts for the clamps. The rupture propagated through the composite material at 45 degrees. Due to the impulse induced by the sudden opening of the forward closure the motor casing was propelled in the opposite of the launch direction. Due to the high acceleration of the motor casing the friction fit between the casing and the aft fin can ring could not keep the motor retained inside the fin can.

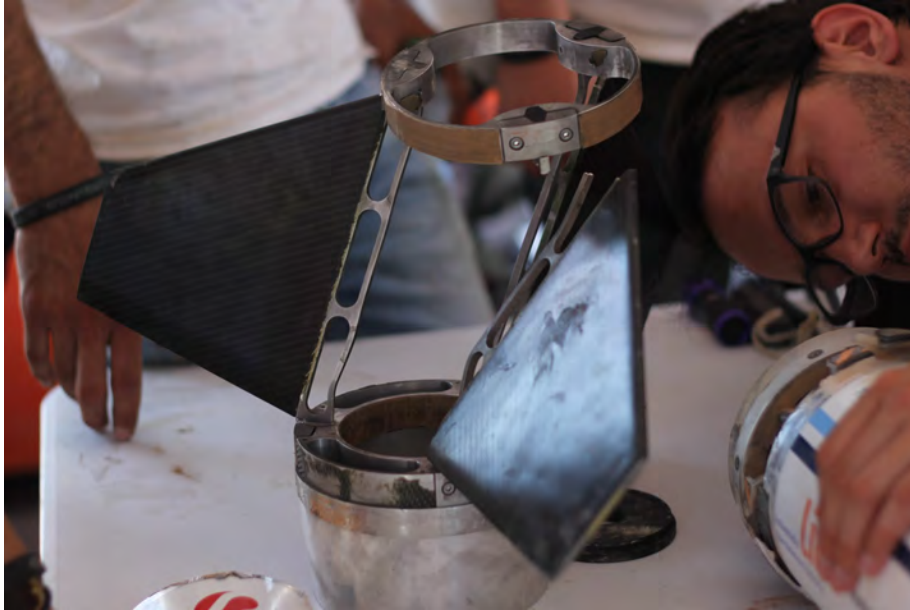
The fin can structure showed major distortions along its vertical axis (see Figure 11). One backbone was ruptured close to its attachment points. However, the sandwich panel construction of the fins showed no obvious signs of damage or distortions. This also applies for the AFT ring, the clamps and the boattail, whereas the FWD ring is slightly deformed.

Figure 11: Distorted fin with partially ruptured backbone, slightly bent upper fin ring and the almost undamaged lower fin ring and boattail

Therefore the disintegrated carbon fiber tube, the motor casing as well as the fin can descended individually. Eventually the circumferential rupture of the tube was caused by the impact on the ground. The same is assumed for the distortion of the fin can. Most probably it tumbled during the descent and touched ground first with the forward aluminium ring. This impact causing the deformation of the forward ring and the distortion of the backbone structure due to the sudden deceleration of the heavy boattail and the resulting compression force acting on the rest of the fin can structure.

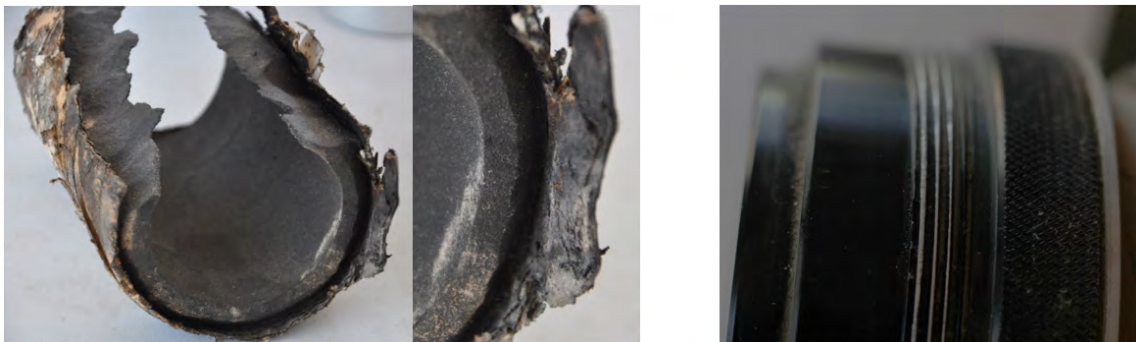
The FWD closure was still attached to its adapter, but separated from the lower part of the motor. The motor casing, AFT closure and nozzle remained assembled and no serious damage is observed on the lower part and on the casing itself. The liner was found outside the casing, chipped on one site, all casting tubes and grains were pushed out. No all grains burned through completely. No adhesive residues were observed in the inside of the liner. The FWD closure and Seal Disk O-rings were located above the motor adapter. All metal parts were intact. After cleaning, the first approximately three threads of the FWD closure exhibited completely worn down teeth. For more information on the motor, contact Alexander Schmid.

Figure 12: State of the grain (two left pictures) and the thread

- The casing clearly shows the signs of a overpressurization. The thread of the FWD closure is worn down on the first three turnings, the load bearing part of any thread.

- Normally, grains extinguish immediately at motor cato due to the sudden pressure drop to atmospheric pressure from burning chamber pressure. The fact that grains continued to burn for a while suggests that the pressure drop was slowed down by pressurization of the lower rocket body.
- Based on the measurements from the remaining propellant, the grain recovered burned 50-60% of its propellant before cato.
- The grain recovered shows anomalies on the backside between the casting tube and the propellant.

'From the photographic evidence and incidental observations made by you and your team, the root cause of the motor failure was: Propellant grain edge burning, the result being the over pressurization of the motor case, causing it to fail forward along its longitudinal axis.'

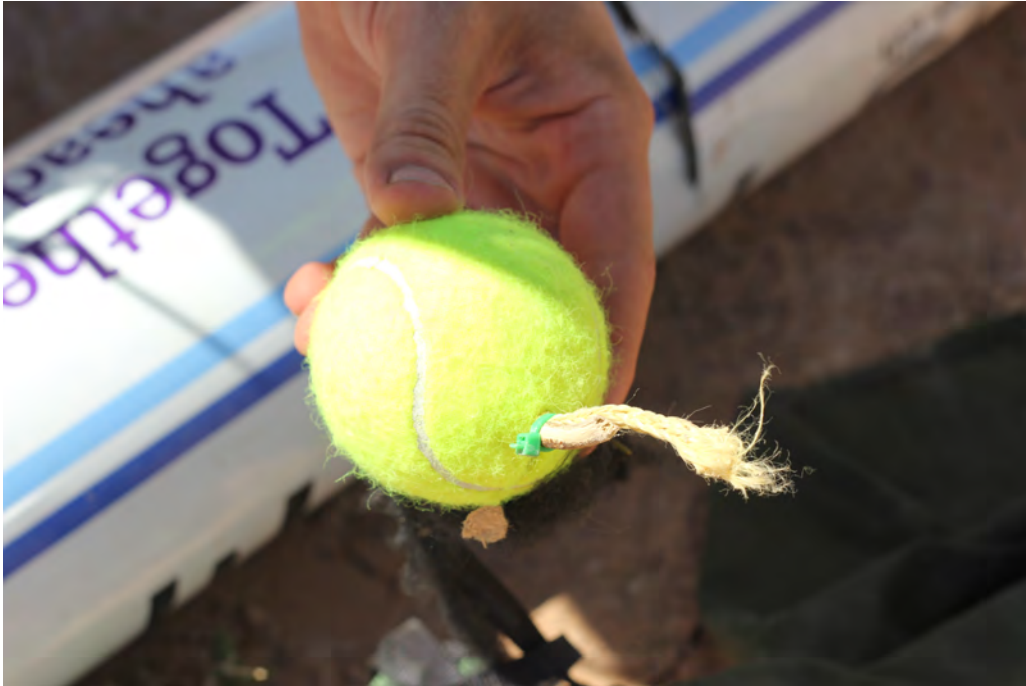
After the explosion, it was observed that the recovery system was ejected prematurely. At some point, the Kevlar cord was disrupted (see Figure 13). The drogue parachute was still attached to the nosecone after ground recovery - it is assumed that it slowed down the descent of the nosecone (see Section 3.1.1). The rest of the rocket landed without any deceleration of a parachute. Not only the cord but also the parachutes and the parachute bag were recovered in a disrupted state (see Figure 14).

Figure 13: The Kevlar chord after ground recovery

The nose cone eventually starts pointing downwards. Its drag and inertia still tensions the kevlar cord which is attached to the main parachute release system. The chord cuts through the carbon fiber tube and is severely damaged in the process which leads to a rupture of the cord.

Due to the motor explosion the COTS flight computer must have triggered the ejection of the recovery system falsely. The ejection was designed to be triggered at apogee where the speed of the rocket should already be decreased. At the point of the explosion, the speed was much higher than it would be at apogee, causing a much higher shock force due to the parachute ejection. This explains the rupture of the parachutes and the kevlar chord.

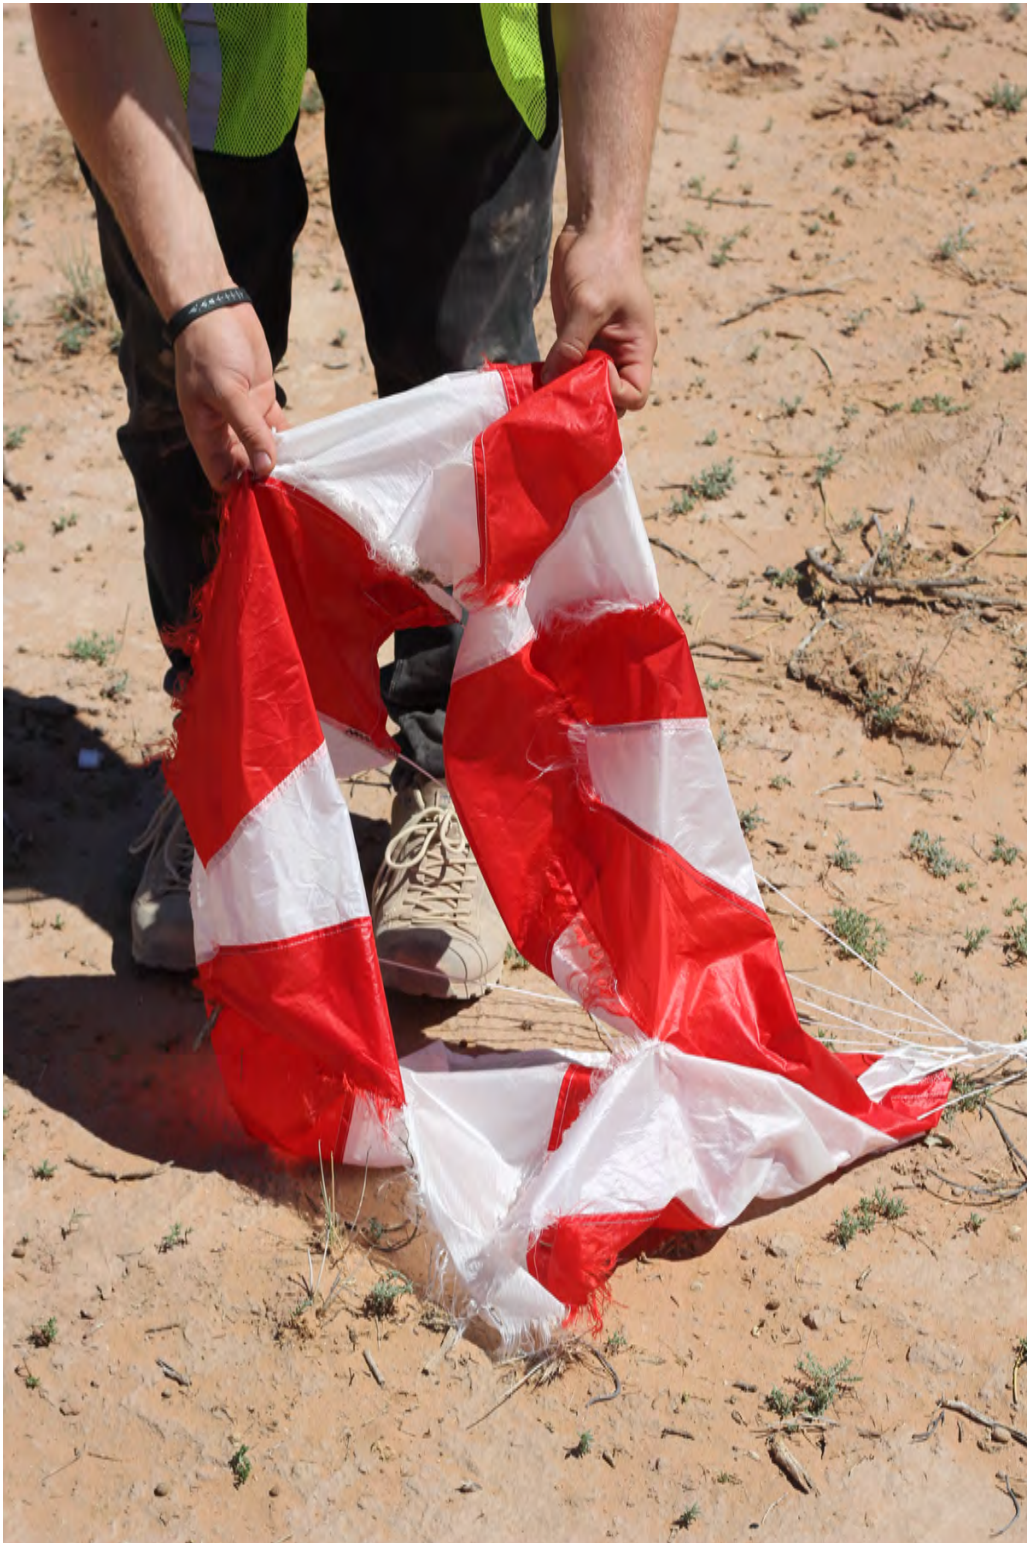
Figure 14: The torn Drogue parachute after ground recovery

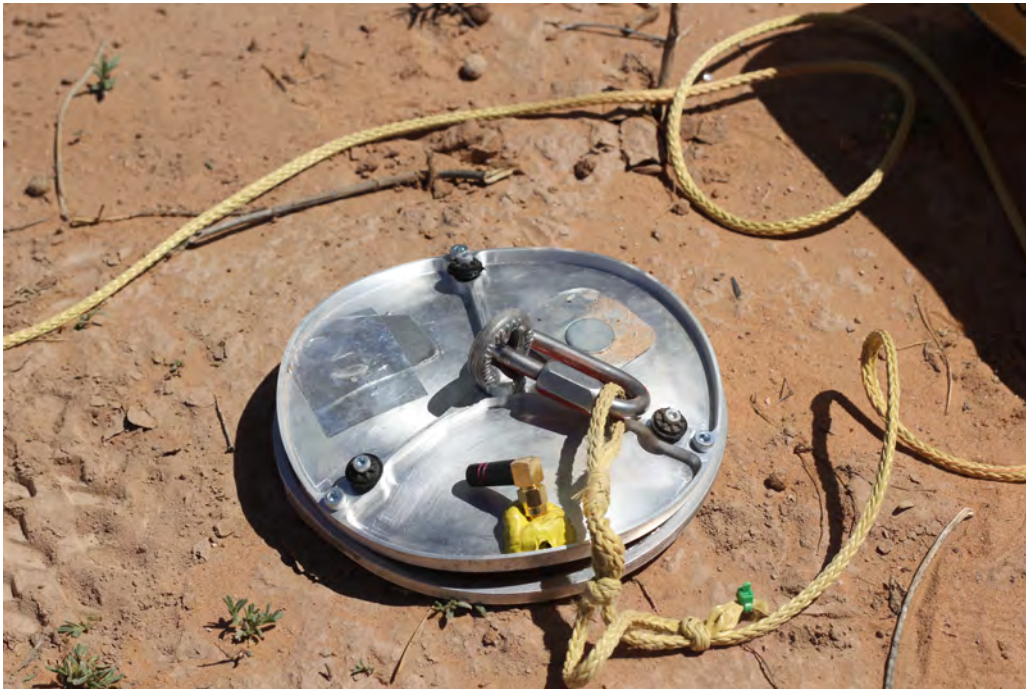
The shock of the explosion or of the touch down destroyed the MDF plate connecting the avionics and the nosecone bulkhead (see Figure 15). As a result of this the avionics were pushed into the nosecone. The 900 MHz antenna and the remaining upper MDF plate absorbed most of the remaining shock, leaving most of the nosecone avionics completely unharmed. Although the GPS antenna and the 2.4 GHz antenna were ripped off and the cables broke, the actual connectors on the side of the main avionics were completely intact. Also the camera cable was completely ripped off (potentially due to the sensitive nature of the PI-Cam, something that also happened during assembly). The nosecone avionics was still beeping at recovery and was still recording data.

Figure 15: The separated nosecone bulkhead which was attached to the lower MDF plate of the nosecone avionics

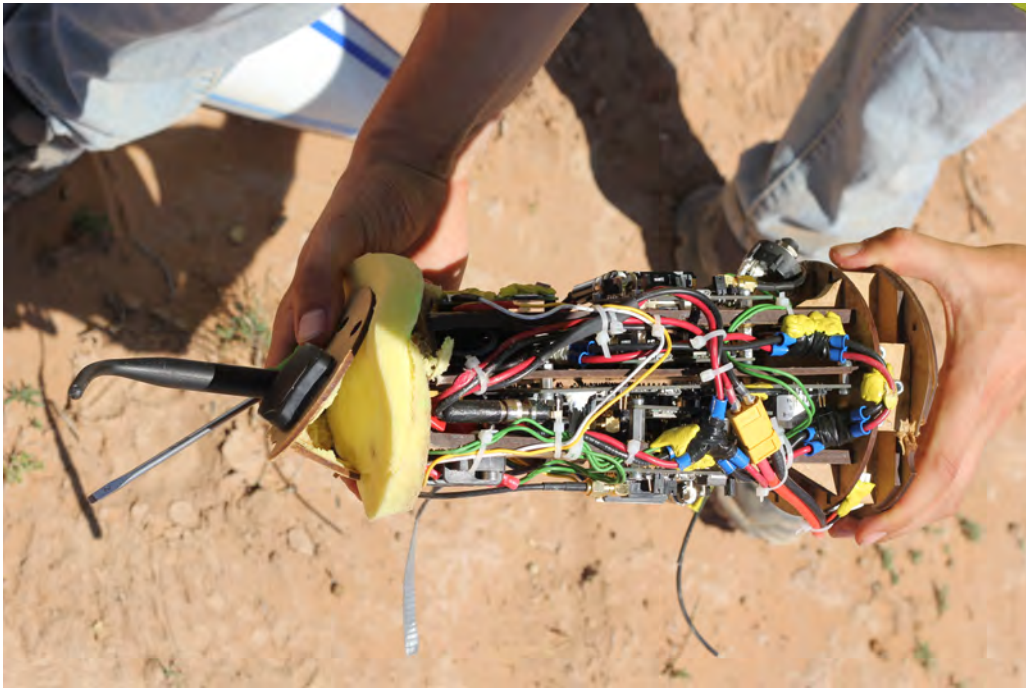
Figure 16: The recovered nosecone avionics with the bent 900 MHz and GPS antenna, and the intact cable ties in the middle connections

- Crimping forms a strong connection, but represents still the weak spot in the connection.
- Soldering was completely reliable and formed very strong connections, however this is due to the fact that only the very big cables of the power connectors (AWG 16) were soldered and this was done very cautious.
- Cable ties were the most reliable solution forming extremely strong friction points which were much stronger than the cables we used.
- Soldering with a vapor phase oven as well as by hand was reliable enough and caused no problems whatsoever during the launch and the explosion.
- All components and connectors that can bend should be avoided (e.g. header pins, power connectors used).
- Through-hole connectors which cannot bend proved to be strong enough and did not represent a weak point.

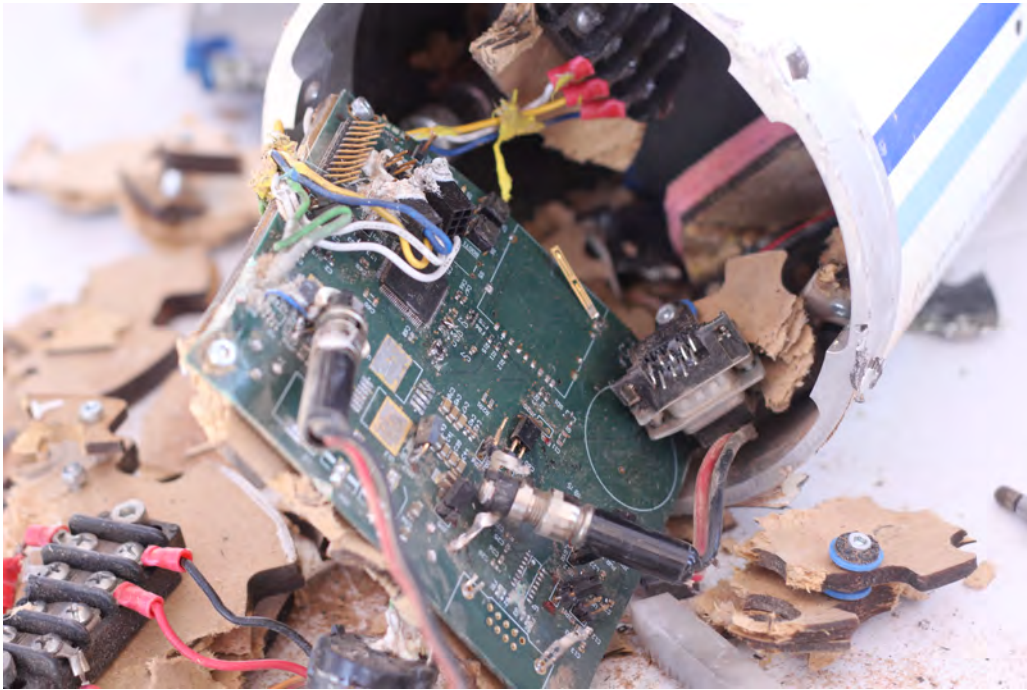
The lower body avionics were completely destroyed. Almost all components were ripped off the lower body PCB plate, potentially due to the tungsten ballast plates. The Xbee PCB in the recovery was in a good state. However, the power connector and the header pins were bent and the cable for the antenna was ripped off. The heavy and beefy antenna and DB9 connectors were completely intact. The cables itself were mostly either broken in the middle or at the crimping point. For more information on the avionics software contact Raphael Schnider, for the hardware contact Alessandro Forino.

Figure 17: Completely destroyed lower body avionics and the PCB with all components ripped off

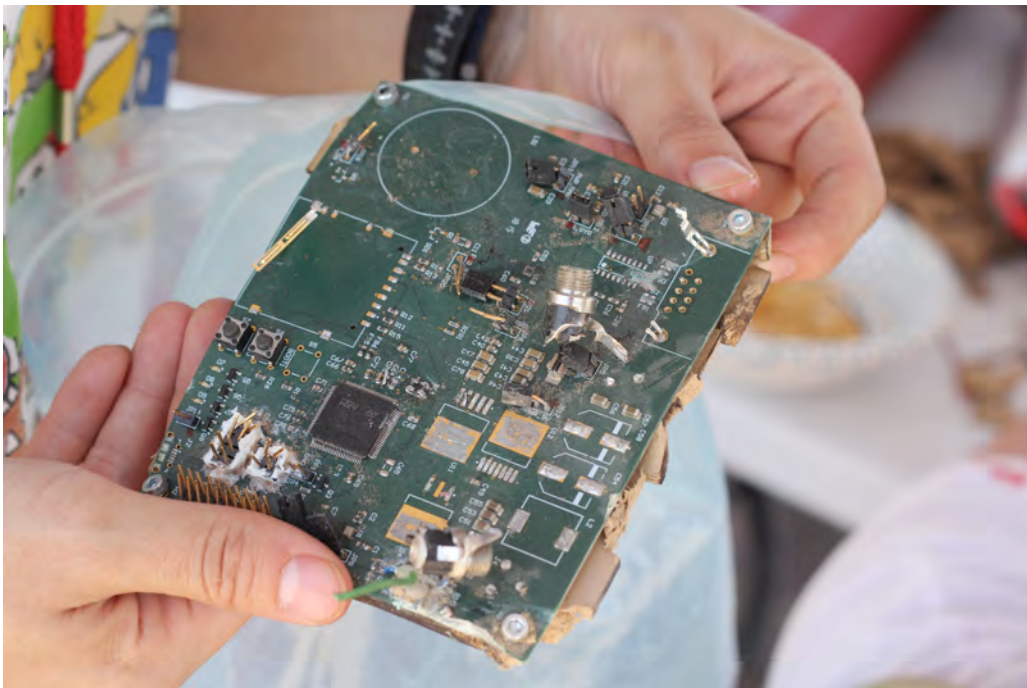
Figure 18: The lower body avionics PCB after the crash

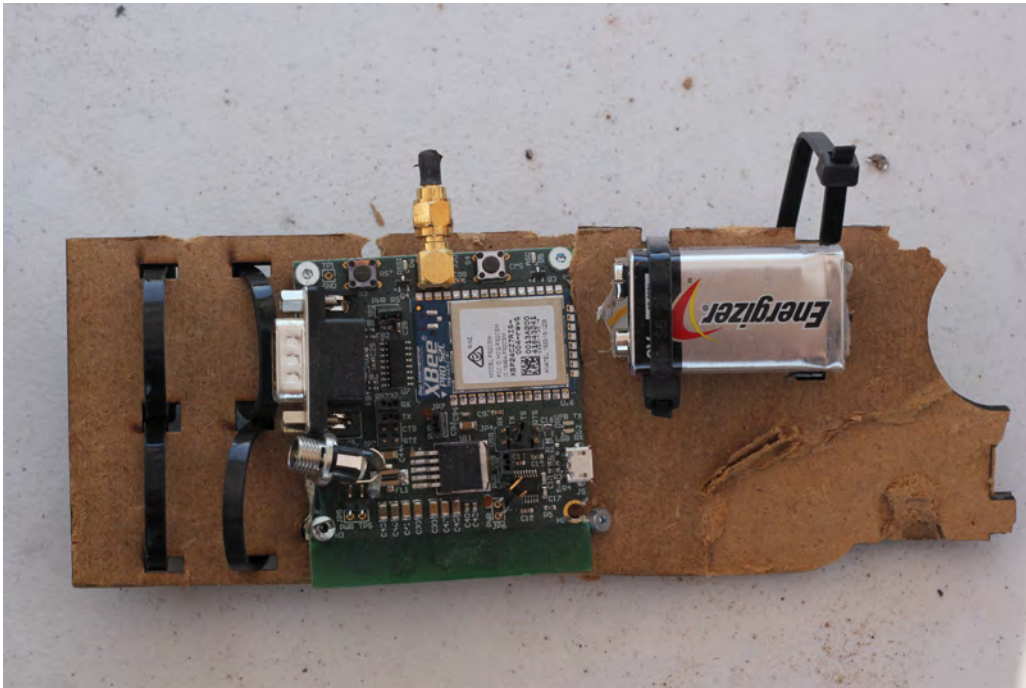
Figure 19: The Xbee module in the recovery bay with bent header pins and power connector; the components are still in place and the other connectors survived

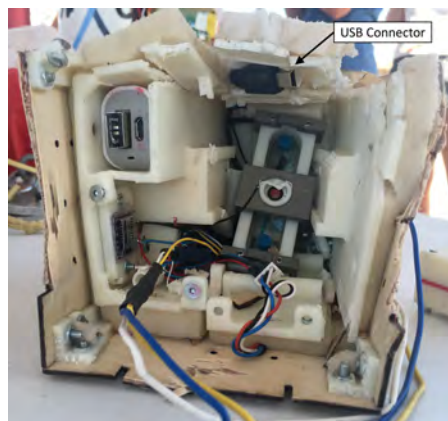
(a) Damage Experiment Top-View

Figure 21 shows the damage of the experiment from top-view and side-view. The microscope was torn from its holder due to the impact of the dummy payload (Fig: 21b ). Due to the resulting high acceleration, the microscope was completely destroyed. No video data could be restored. For more information on the payload contact Bruno Fruttig.

Although the payload was severely damaged, the acceleration values could be restored. These rise rapidly after launch to almost 17g and then abruptly abort. In Figure 21a it can be seen, that the USB connector on the Arduino is no longer plugged in, even though it has been aligned so that the acceleration of the rocket pushes it into its socket. That the free fall of the rocket can not be recognized in the data can be explained by the fact that the USB plug was pulled out of its socket by the abrupt deceleration of the experiment after rocket failure which corresponds to a high

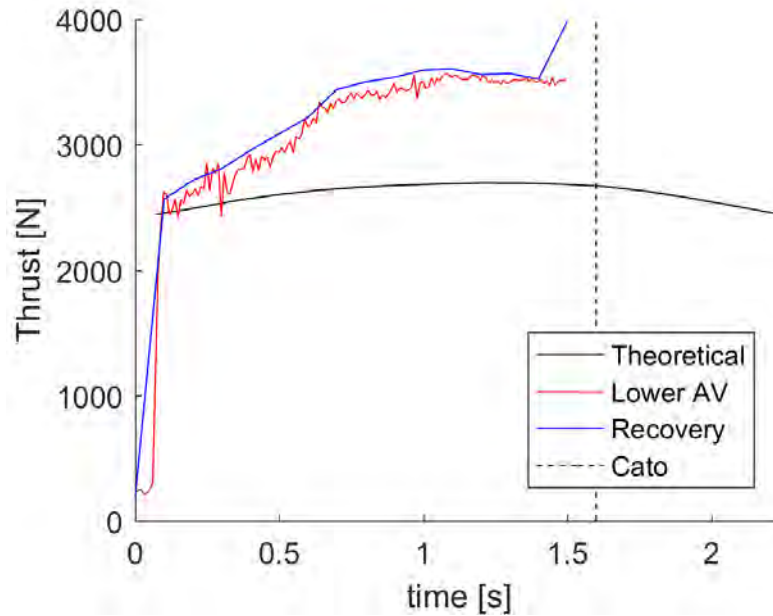
Figure 22: Recalculated and nominal thrust versus time during launch and shortly before cato.

Starting at nominal thrust, the motor shows progressive burn to high thrust values. With a peak thrust of nearly 3600 N, the motor exceeded its nominal max.  $T$  by one third. The individual sensor datasets correlate to a large degree, cross validating the information obtained. This is important for two reasons, one being the SRAD character of the rocket's avionics and the other the possibility for damaged, corrupted data as a consequence of the non-nominal flight event. The recalculated thrust curves show that the motor performed out of its nominal range. Such an observation can be made if the propellant's burning rate is higher than planned or the nozzle throat is not properly dimensioned. In both cases, the next level cause is higher chamber pressure, forcing the gas to be expelled at larger velocities and causing larger thrust values.

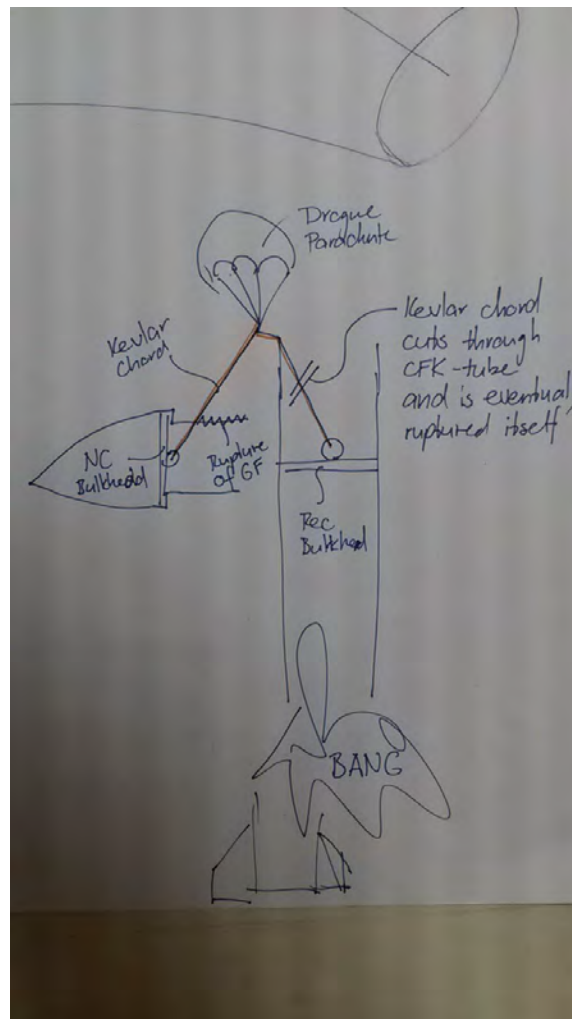
It is assumed that the apogee detection system triggered the CO<sub>2</sub> system to eject the nose cone and the drogue chute right after the explosion of the motor. This caused the nose cone to separate from the rest of the airframe. The airframe however was still ascending along its initial trajectory.

This leads to the nose cone not being propelled anymore and being tilted sideways. The kevlar cord cutting is then tensioned and cuts through the coupler section of the nose cone while the nose cone continues tilting.

Figure 23: Sketch of a possible explanation of events which led to the separation of the nose cone and the drogue parachute from the main airframe

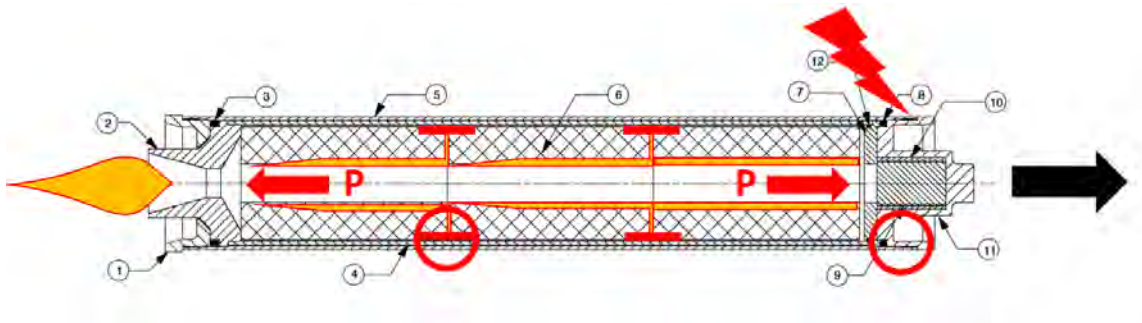
In conclusion to the recovered parts and discussions with experts, it can be stated that the COTS motor failed. Due to propellant grain edge burning, an over pressurization occurred causing the flight of TELL to fail.

Figure 24: Depiction of irregular grain burning, leading to over pressurization and the failure where the motor was attached to the structure
