# Post Flight Analysis Report

## Project TELL - Spaceport America Cup 2018

<b>Doc. Reference</b>	TELL_FR01_Post_Flight_Analysis_01
<b>Author</b>	Alex Schmid (alexschm@student.ethz.ch)
<b>Co Authors</b>	Anna Kiener David Haeusermann Bruno Frutig Ziga Brencic
<b>Date</b>	17-May-2019

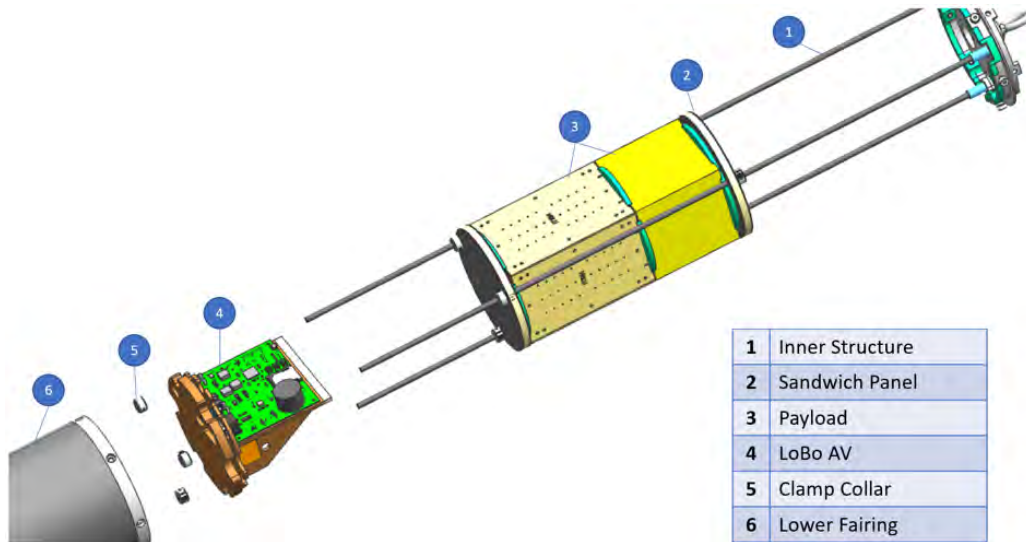
Figure 20: CAD model of the inner structure and the position of the payload

The payload section was severely damaged by the 3 kg tungsten ballast mass located directly above the experiment. This ballast was actually mounted as part of the overall payload and was torn out of its support during the impact. It struck the experiment and made the payload useless for further experiment evaluation.
